Monitoring of Entrance Channel Navigation Improvements at Morro Bay Harbor, Morro Bay, California

September 2002

Final report

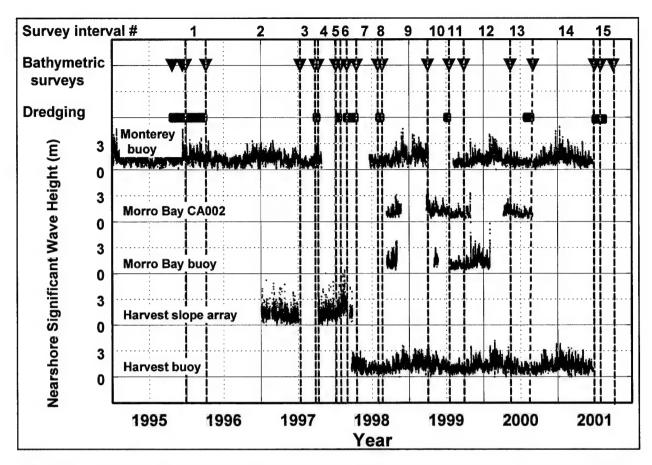
Figure 13. Time-history of nearshore significant wave heights from available sources, bathymetric survey intervals, and dredging activity; offshore sources are transformed to Morro Bay Harbor entrance (some survey intervals when dredging was in progress are not numbered since they are not appropriate for bathymetric change analysis)

The figure provides a useful overview of wave conditions during the monitoring project. For example, wave heights were consistently low throughout interval 11 and intervals 9, 12 and 14 experienced several major storm time

The Morro Bay buoy is noted to have several unusually high significant wave heights, up to 6 m (19.7 ft), during interval 12. Other sources indicate energetic storms at the same times, but significant heights are considerably lower. Contrary to other gauges, this buoy is in a location where waves may be strongly modified by rapid tidal currents through the breakwater gap, shallow bottom, and wave breaking. In highly energetic events, the buoy response to sea surface fluctuations may even be distorted in ways that are not compensated in the data analysis. Thus, data from this buoy should be treated as localized information.

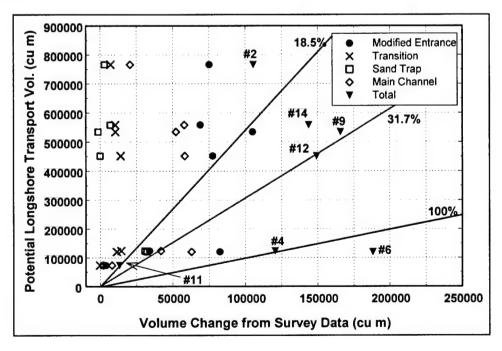
Potential gross longshore transport volumes computed from wave time-histories are given in Table 8 along with summarized volume changes from survey data. The relationship between them is varied (Figure 27). Although volume changes are shown for project segments (e.g., modified entrance, transition area, etc.), the total volume change is considered most meaningful. For the two shortest non-summer survey intervals (No. 4 and No. 6), the total volume change from survey data equals or exceeds $Q_{\rm g}$. This suggests that 100 percent of the gross longshore transport was captured in the newly-dredged project during these two stormy survey intervals. For longer survey intervals, total volume change is less than one-third of the potential gross longshore transport volume. The data suggest that, over time intervals on the order of 1 year, around 15-30 percent of the gross longshore transport may be retained in the dredged project.

Figure 27. Potential gross longshore transport volume versus volume change from survey data; survey interval numbers included; lines indicate representative percentages of potential longshore transport volume

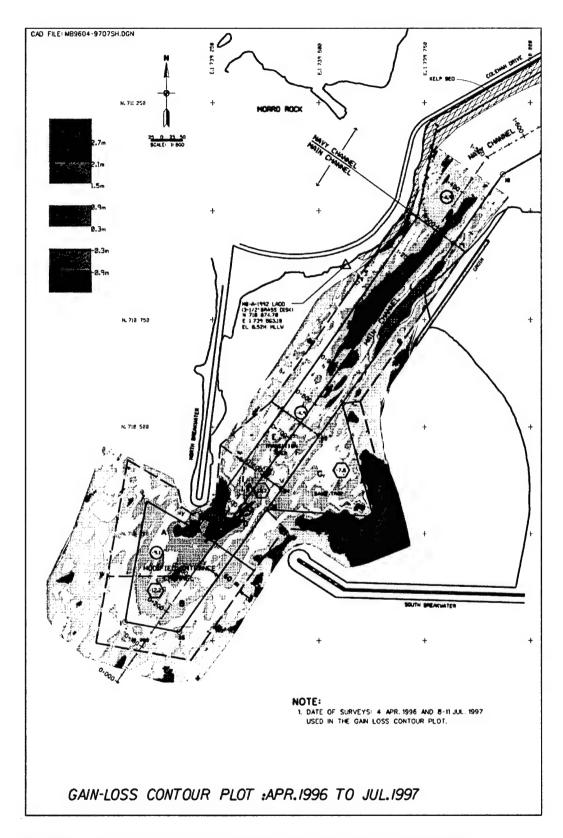
Figure C1. Bathymetry changes at Morro Bay entrance between 4 April 1996 and 8-11 July 1997

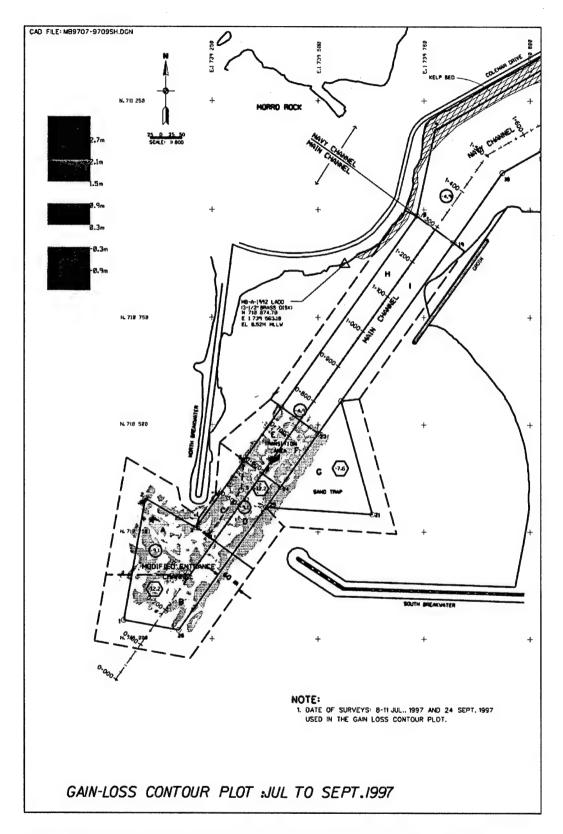
Figure C2. Bathymetry changes at Morro Bay entrance between 8-11 July 1997 and 24 September 1997

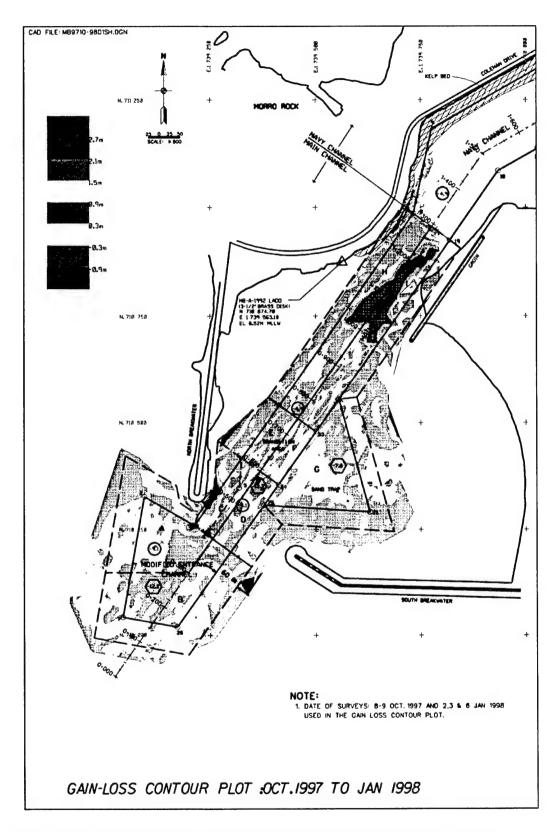
Figure C3. Bathymetry changes at Morro Bay entrance between 8-9 October 1997 and 2-6 January 1998

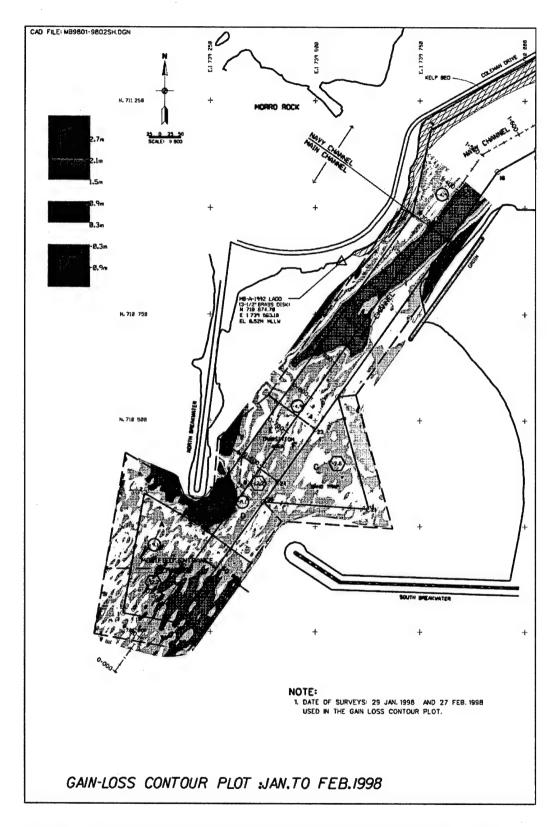
Figure C4. Bathymetry changes at Morro Bay entrance between 29 January 1998 and 27 February 1998

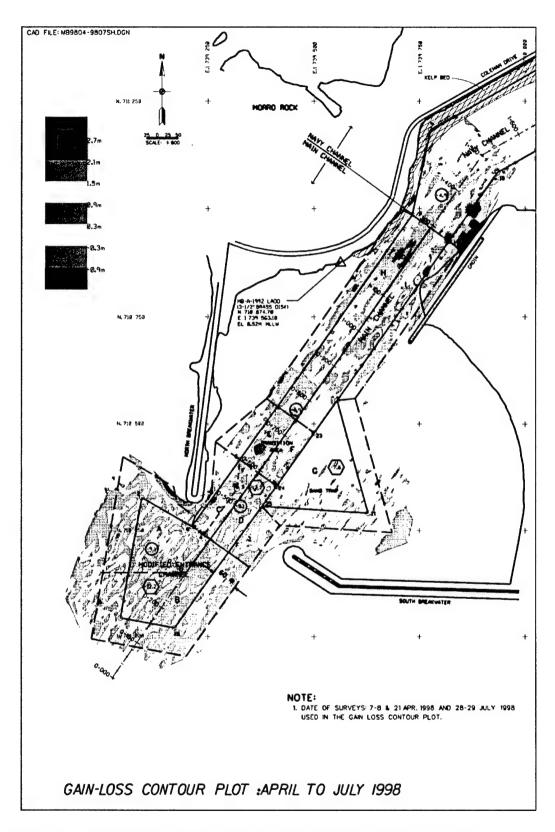
Figure C5. Bathymetry changes at Morro Bay entrance between 7-21 April 1998 and 28-29 July 1998

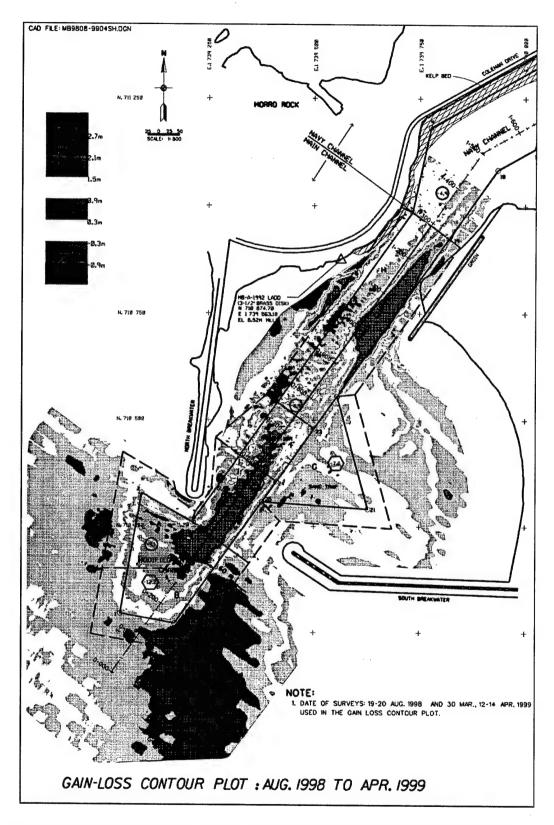
Figure C6. Bathymetry changes at Morro Bay entrance between 19-20 August 1998 and 30 March-14 April 1999

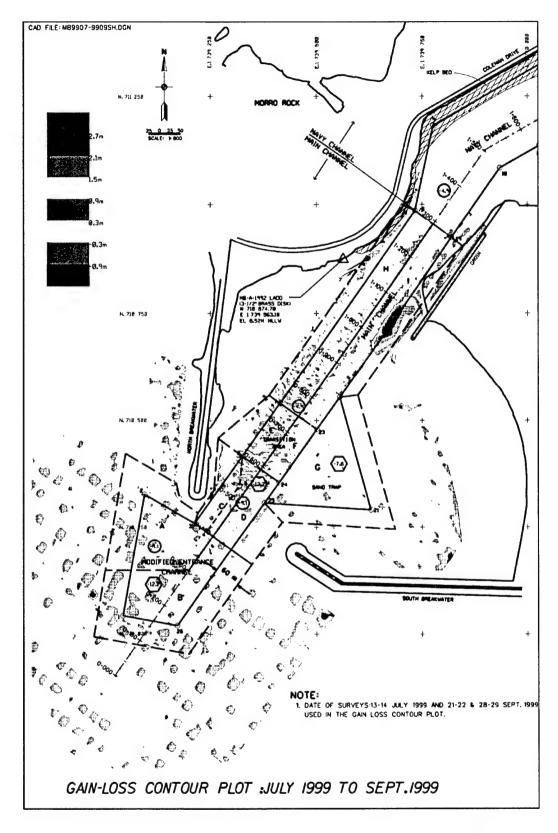
Figure C7. Bathymetry changes at Morro Bay entrance between 13-14 July 1999 and 21-29 September 1999

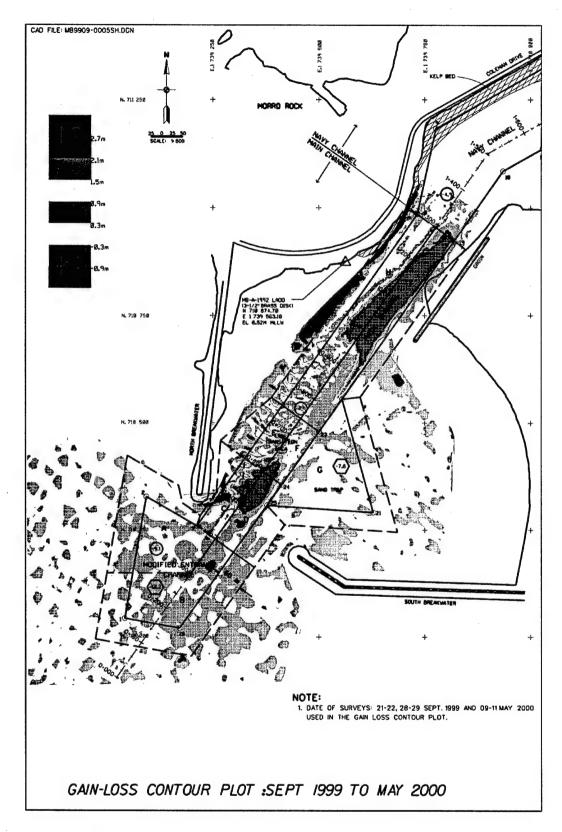
Figure C8. Bathymetry changes at Morro Bay entrance between 21-29 September 1999 and 9-11 May 2000

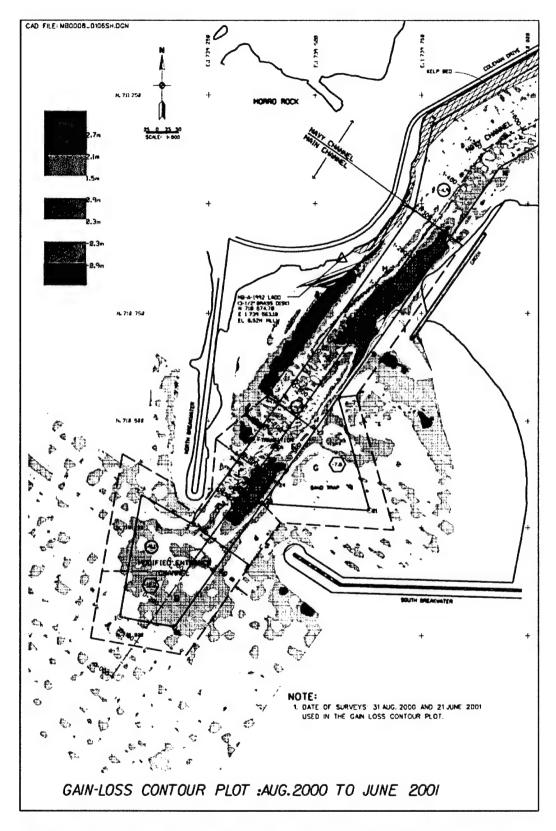
Figure C9. Bathymetry changes at Morro Bay entrance between 28-31 August 2000 and 19-21 June 2001

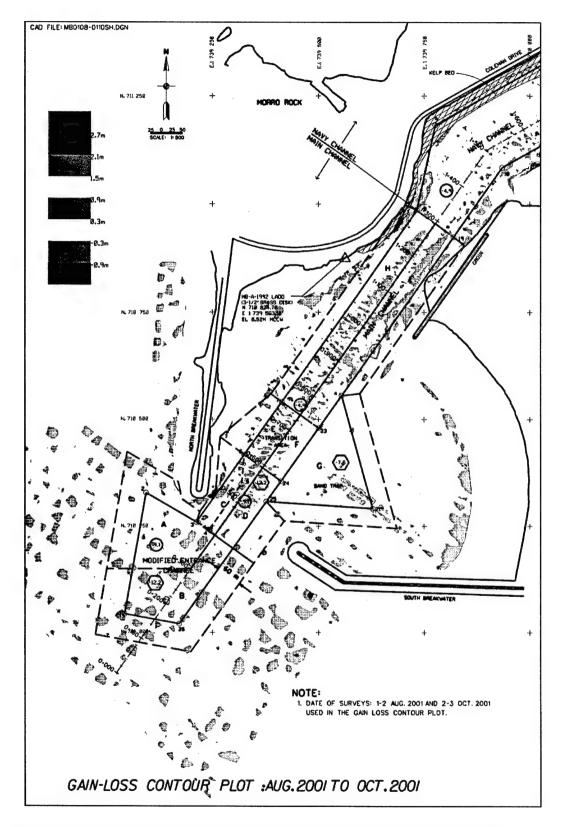
Figure C10. Bathymetry changes at Morro Bay entrance between 1-2 August 2001 and 2-3 October 2001

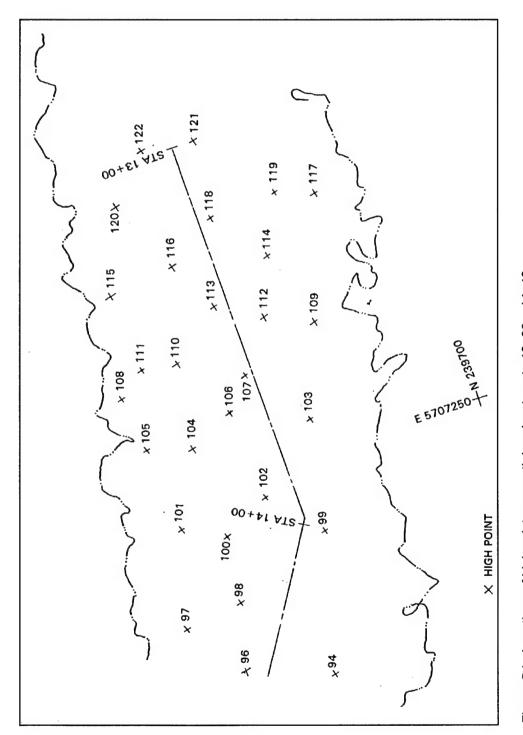
During the photogrammetric analysis, the high points on 122 individual armor stones, scattered thoughout the monitored structure, was obtained and x, y, and z coordinates were noted in the 1998 survey. These points were not targeted, but selected from the stereomodel. The identical horizontal coordinate points were revisted during the 2000 survey and elevations obtained in an effort to determine if movement had occurred. The locations of the high points of the stones are shown in Appendix G. The coordinates of these points, elevations for the 1998 and 2000 surveys, and differences in elevations are presented in Table 10. Changes in elevations of only five of the 122 high points were greater than 0.3 m (1 ft). The average change in elevation of the remaining 117 high points was only 0.037 m (0.12 ft). The maximum elevation change was -1.314 m (-4.31 ft) at high point 51, located on the harbor side of the structure at sta 16+49. Also on the harbor side of the breakwater, high points 25 at sta 17+60. 45 at sta 16+73, and 79 at sta 15+23 lost 0.783, 0.53, and 0.338 m (2.57, 1.74, and 1.11 ft) in elevation, respectively. High point 80, situated on the sea side of the structure at sta 15+09, lost 0.756 (2.48 ft) in elevation.

Figure G1. Locations of high points on south breakwater, sta 13+00 - 14+40

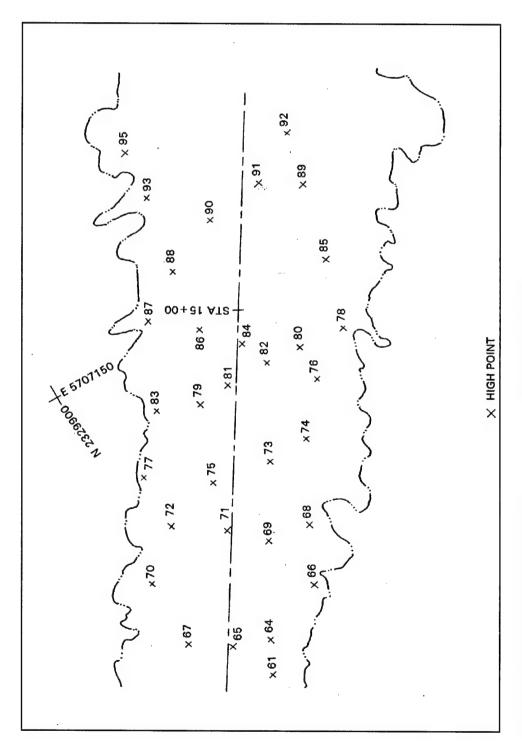
Figure G2. Locations of high points on south breakwater, sta 14+40 - 15+94

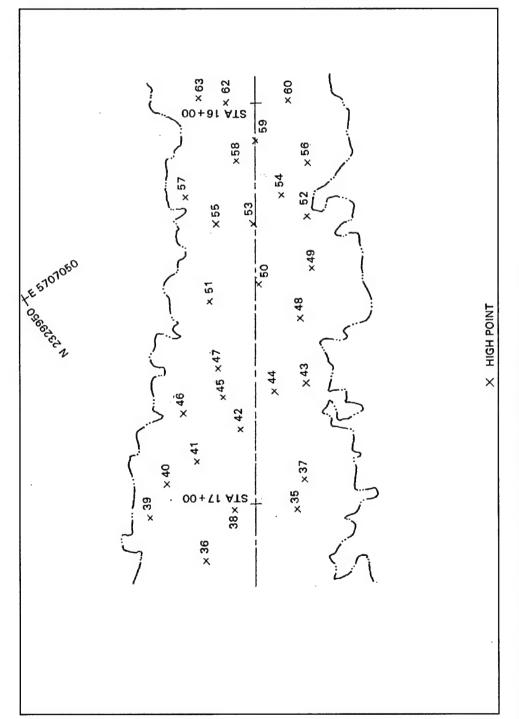
Figure G3. Locations of high points on south breakwater, sta 15+94 - 17+20

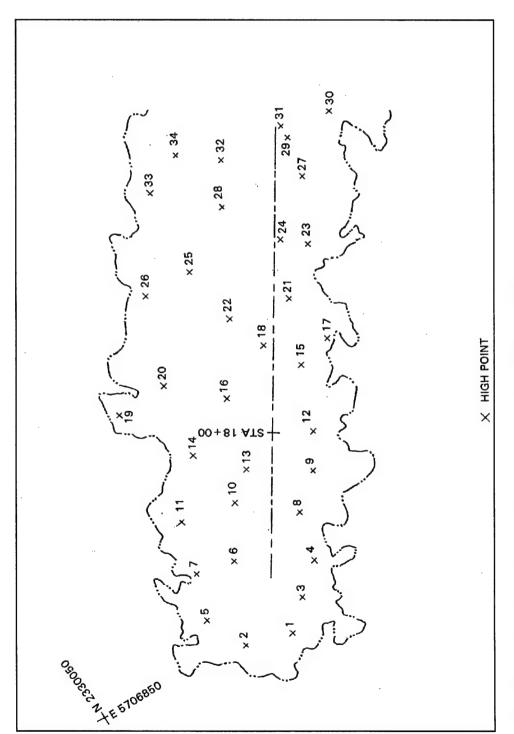
Figure G4. Locations of high points on south breakwater, sta 17+20 - 18+50
